Visual diagnosis of roads and slope stability design in the Potosí sector – Ciudad Bolívar

John A. Amaya, Giovanni A. Vargas, Jhon V. Acevedo, Henry Y. Bustos

¹*Department of Engineering, Faculty of Civil Engineering
Corporación Universitaria Minuto de Dios – UNIMINUTO, Bogotá, COLOMBIA*

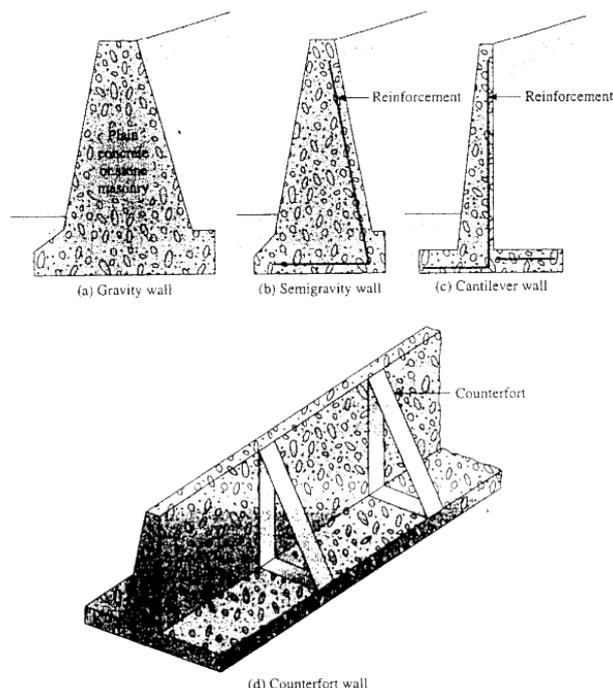
Fig. 1. Types of Containment Walls. [12]

The gravity walls: they are built with concrete or cyclopean masonry. They depend on their own weight and any ground support on the structure for stability. This type of construction is not recommended for high walls, it can represent high costs. In many cases, the steel can be used for the construction of gravity walls, minimizing in this way the size of wall sections. Such walls are generally known as semi-gravity walls.

Reinforced walls: they are made of reinforced concrete consisting of a thin spur and a base slab. This type of wall is economical up to a height of around 8m. Fig. 1 shows a reinforced retaining wall under the wall under construction, and when compared with the other types of wall, the decrease in cross section is evident, which makes it economically and spatially viable.

Buttress walls: they are similar to reinforced walls. However, at regular intervals they have thin slabs of vertical concrete known as abutments, which join the wall and the base slab. The purpose of the abutments is to reduce the shear stress and the bending moments. [1]

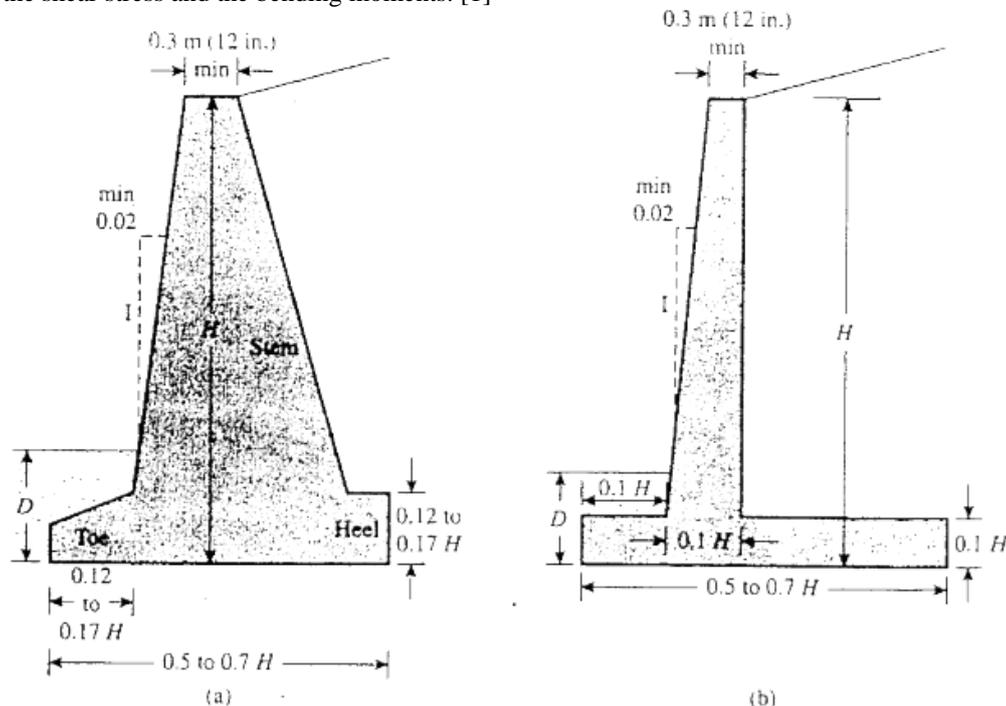
Fig. 2: Approximate dimensions of the various retaining wall components for the initial stability controls: (a) gravity wall, (b) cantilevered wall [12]

For the case of this document, we chose cantilevered or reinforced wall designs.

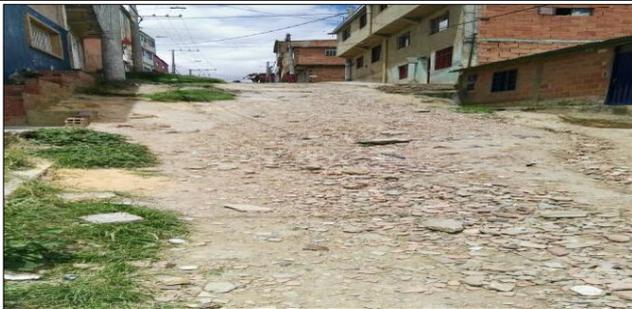
Tab for data collection 101			
Visual diagnosis of roads and slope stability design in the Potosí sector – Ciudad Bolívar

LOCATION			
TRACK SECTION	CIV	Road Section	Mesh Type
CL 77 SOUTH BETWEEN KR 44B Y KR 45	19005077	V9	Local
PHOTOGRAPHIC RECORD

CHARACTERISTICS OF THE ROAD SECTION			
PRESENTS SEWERAGE		YES	
PRESENTS ROCK BODIES		DO NOT	
TYPE OF PAVEMENT		AFFIRMED	
PRESENTS DAMAGE TO THE PAVEMENT		YES	
PRESENTS OR IS IN STUDY AND DESIGN THE ROAD		DO NOT	
DIMENSIONS OF THE ROAD SECTION			
ROAD AXIS (m)	INITIAL WIDTH (m)	FINAL WIDTH (m)	
36.6	6.6	5.8	
REQUIRED INTERVENTION			
(Measurement scale from 0 to 2, where 0 does not require intervention and 2 requires immediate intervention)			
0	1	2	<u>X</u>
OBSERVATIONS			
No platform on either side Requires construction of road mesh and walk Unpaved road

Fig. 1: Example sheet of the Visual Diagnosis of Roads. Source: Own creation

From this diagnosis a book was generated and given to the community. The document includes an elaborate data sheet (see Fig. 3) that contains the technical data collected from each of the road sections. A total of two hundred and eighteen (218) cards were made with the data of each section found in the sector. Also, for the sections of paved roads, a diagnosis of pathologies present in the pavement was made, both for rigid and flexible pavement, taking as reference the guidelines of the Visual Inspection of Flexible Floors manual [18] and the INVIAS Visual Inspection of Rigid Pavement [19]. (Although some sections of the roads were paved, they were not necessarily in good condition). From the diagnosis was generated a plan that contains the information of the type of pavement of each section of the roads of the entire area that includes the neighborhoods of Potosí, Las Brisas and Jerusalem in Ciudad Bolívar.

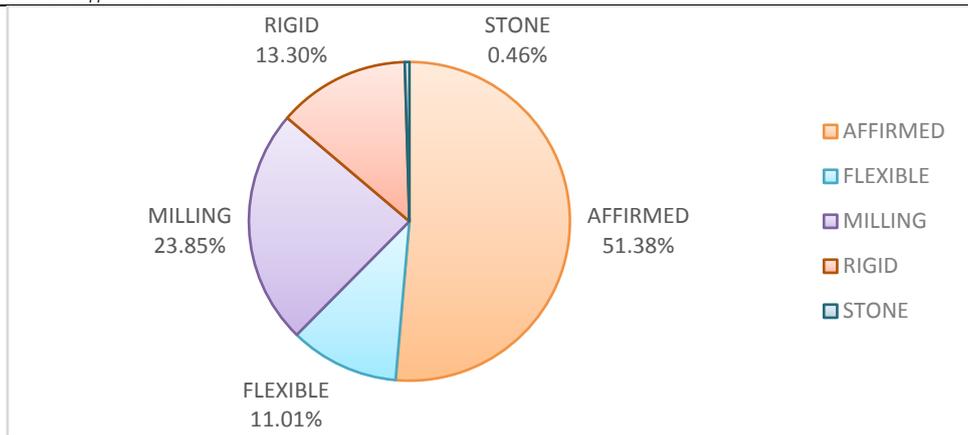
Fig. 2 : Total percentage of sections according to types of pavements. Source: Own creation.

From the study carried out it can be established that more than 50% of the roads do not have a pavement structure (affirmed or mill). This represents a potential risk for the inhabitants of the sector considering that due to the difficult topographic conditions, the displacement is very difficult for anyone, but it is even more difficult for people with disabilities, elderly people, pregnant women and children. The displacement of people would be even more dangerous depending on how optimal are the weather conditions. The results of the study carried out are the following:

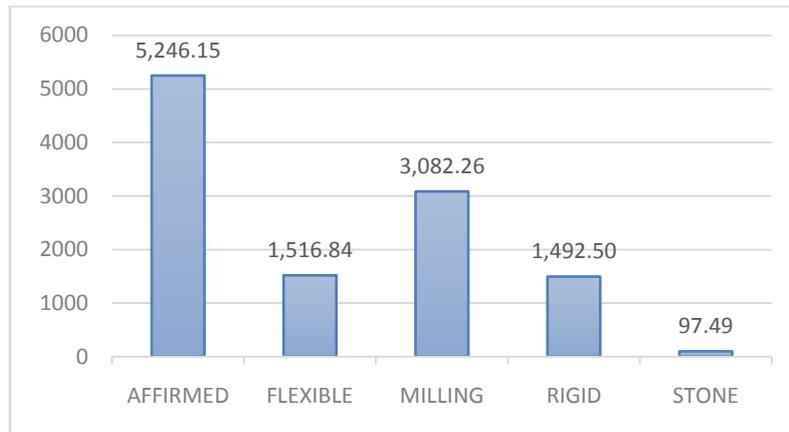
Fig. 3 : Total meters according to types of pavements. Source: Own creation

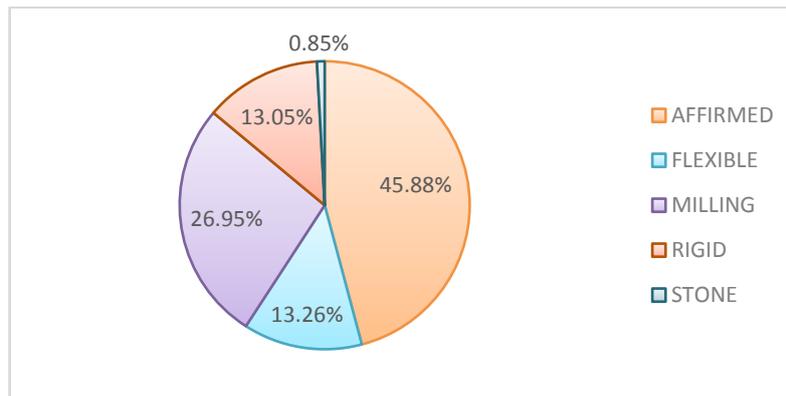
Fig. 4: Total percentage according to length obtained from the different types of pavements Source: Own creation.

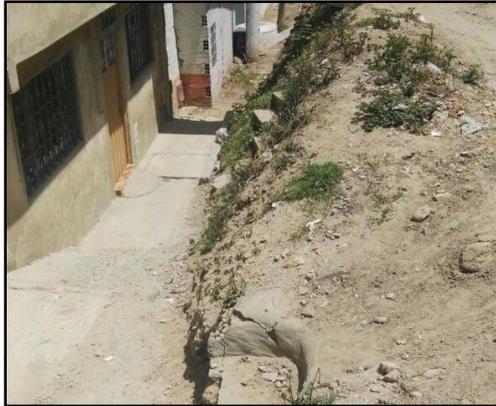
Slope 1 – KR 44 between CL 76 SUR and CL 78 SUR

Fig. 9: Slope 1 Source: Own creation.

Topographic plans were made with their respective transversal cuts for each slope, the cross section is taken at the critical point of the slope, that is, the point where the height and the slope are greater; This is due to

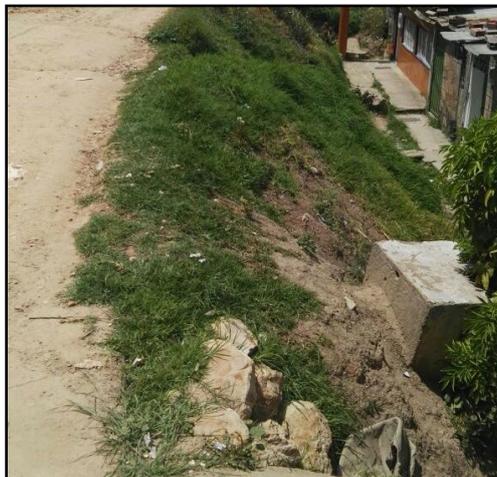
Slope 2 – KR 43 between CL 77 SUR and CL 78 SUR

Fig. 10: Slope 2 Source: Own creation.

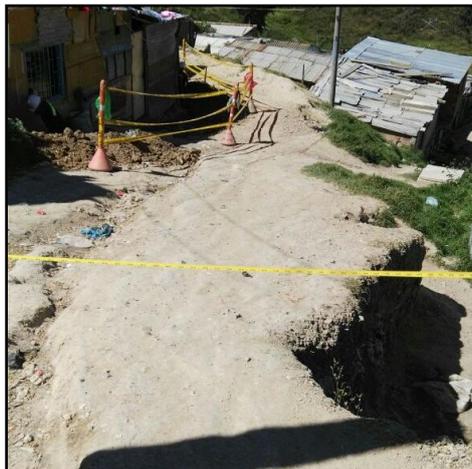
Slope 3 – CL 82C SUR between KR 45 and KR 45B

Fig. 11: Slope 3 Source: Own creation.

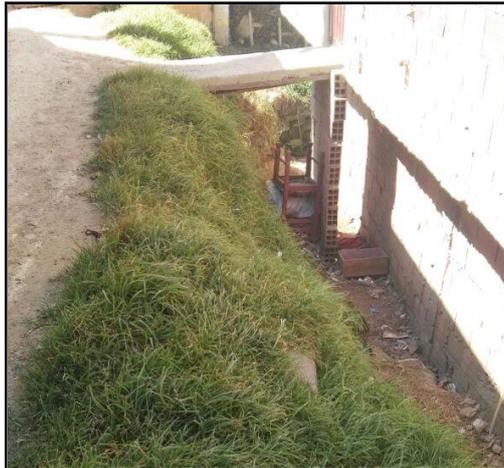
Slope 4 – KR 46A between DG 82A SUR and CL 72B SUR

Fig. 12: Slope 4 Source: own creation

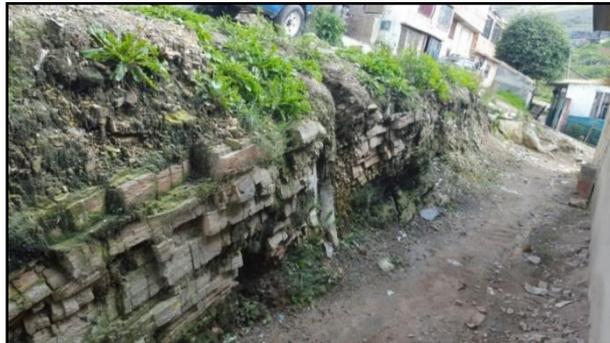
Slope 5 – CL 81 SUR between KR 38 and KR 39

Fig. 13: Slope 5 Source: own creation

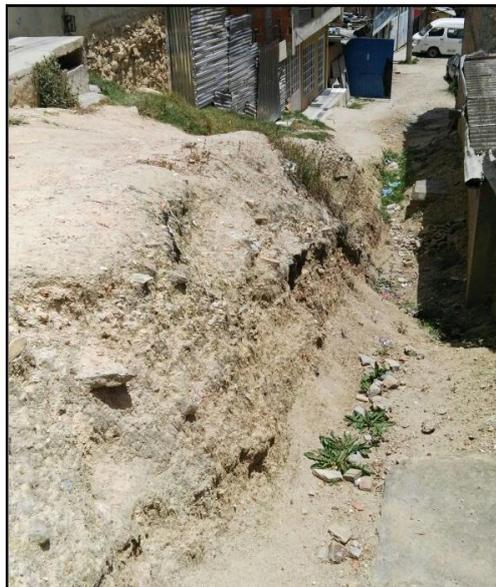
Slope 6 – KR 40 between CL 77 SUR and CL 78 SUR

Fig. 14: Slope 6 Source: own creation

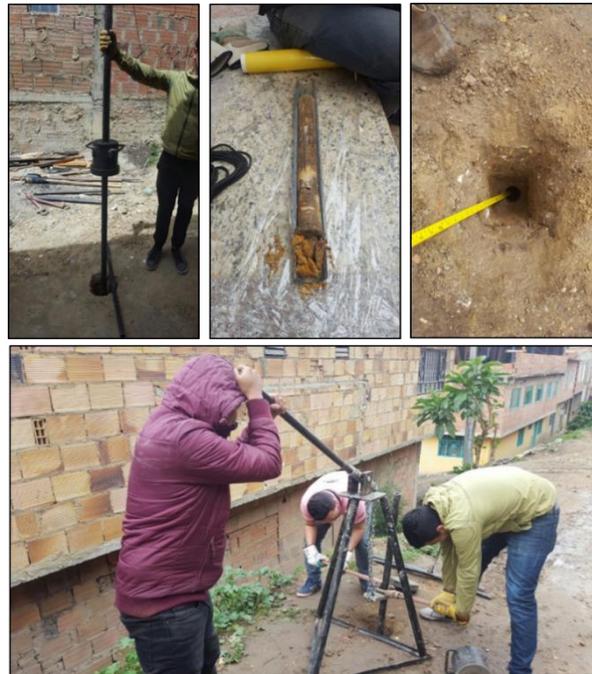
For the in-situ soil explorations, SPT perforations were made, two (2) per slope: one in the top and the other in the base of the slope. Considering that there were 6 slopes to be evaluated, twelve (12) explorations were made in total. The penetration was until reaching the point of rejection (more than 50 strokes) or up to the maximum height of each slope.

Fig. 15: Soil exploration in-situ. Source: own creation.

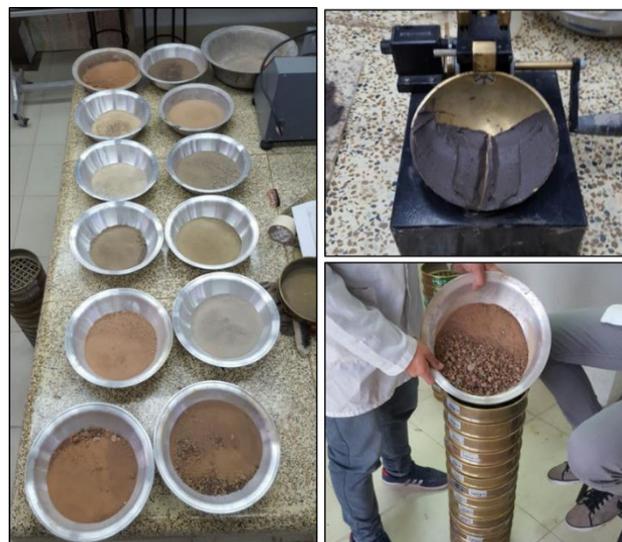
Fig. 16: Laboratory tests. Own source

The laboratory tests were carried out with the samples obtained from the SPT, where they were tested for granulometry by sieving, natural humidity, limits of Atterberg, unit weight by paraffin and soil classification. Direct cutting tests were not performed due to the fact that under ideal conditions, the samples have to be

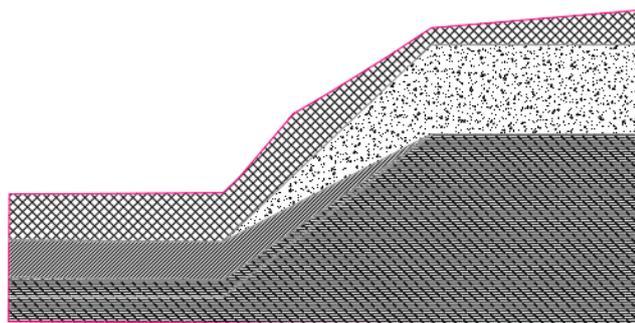
Stratigraphic profile Slope 2	
Layer	Material
CP	Poorly graded sand with the presence of silt
1	Sand poorly graded coffee with traces of rust
2	Poorly graded orange sand
3	Poorly graded sand with low plasticity slime

Fig. 17: Stratigraphic profile - Slope 2. Source: own creation

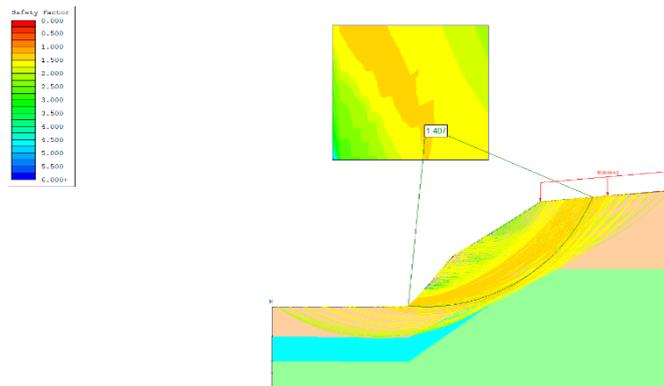
According to the NSR-10 standard, the minimum safety factor for slope stability is 1.5. The selected slopes are modeled below, in case that the slope has a safety factor less than 1.5, it is necessary to carry out a stabilization design for that slope. All the analysis models were developed by the software Slide 6.0 which is ideal for the analysis of slope stability and, all the data, with which the analyzes were fed, were obtained in the calculations of the laboratory tests and the correlations of the SPT test. The analyzes were developed with overloads of 50kN / m² that simulate the efforts on the top of the slope, which the ground would have to support for vehicular traffic and machinery.

Fig. 18: Static Analysis – Slope 2. Source: own creation
 FS=1.407 DOES NOT MEET, requires stabilization design.

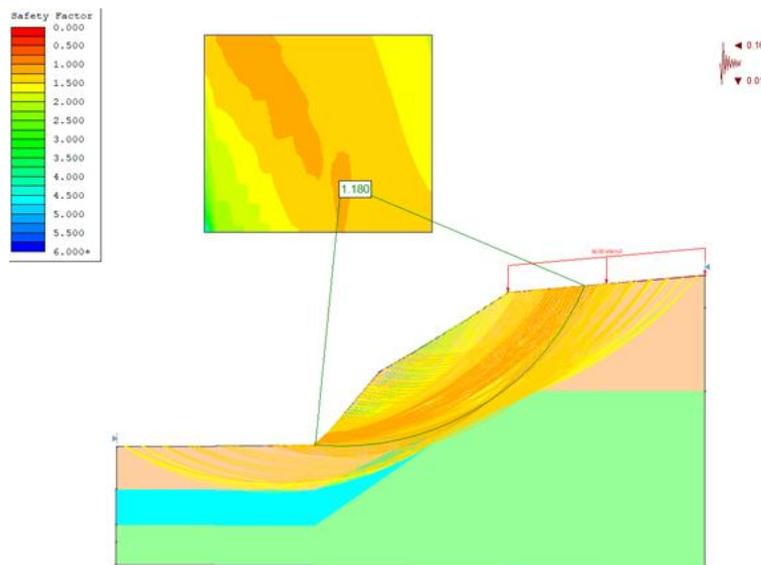
For the dynamic case, what must be taken into consideration is the possible effects of an earthquake on the structure. For this case as for the static case, the standard sets a minimum-security factor for the slope, however, and unlike the static case, this Security Factor is 1.05. All the models of analysis were developed using the software Slide 6.0, ideal for the analysis of slope stability. All the data that contributed to the analyzes were obtained in the calculations of the laboratory tests and the correlations of the SPT test. However, for the dynamic case, it has to be considered the factor of spectral acceleration (acceleration that is necessary to load the model). This factor was obtained from the seismic microzoning of Bogotá (for this specific case) from where a coefficient of horizontal seismic force of 0.16 was obtained and a vertical one of 0.016. This applies only to Zone 5 (see Bogota seismic microzoning). The analyzes were carried out with overloads of 50kN / m² which simulate the efforts in the top of the slope, which would have to support the ground for vehicular and machinery traffic.

Fig. 20: Dynamic Analysis Source: own creation

FS=1.180 MEETS, but it requires stabilization design since it does not meet the safety factor for the static case. (It is necessary that the safety factor meets the static and dynamic case)

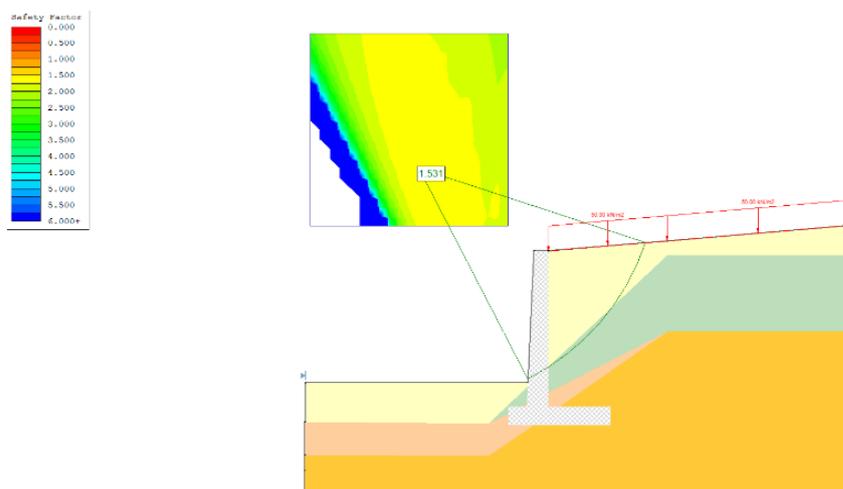
Static case with containment structure

Fig. 21: Static Analysis with containment structure. Source: own creation

FS=1.531 MEETS

For the design of stability, cantilever walls were made on all the slopes. They were designed at the midpoint between the base and the top of each slope, in this way, the stabilization structure is optimized, because by constructive methods, it is difficult to extract very large volumes of earth. Also, it does not require large amounts of filler, which can get to change the physic-mechanical characteristics of the soil to be stabilized. To make these designs, it is necessary to consider four (4) important aspects, which the structure has to meet according to the NSR-10. These four aspects are:

- Slip safety factor, it must be equal or higher than 1.5
- Safety factor due to overturning, it must be higher than or equal to 2 for pseudostatic design.
- Safety factor for carrying capacity, must be higher than or equal to 3.0.
- General safety factor for the structure, it must be higher than or equal to 1.5 for the static case and 1.05 for the dynamic case.

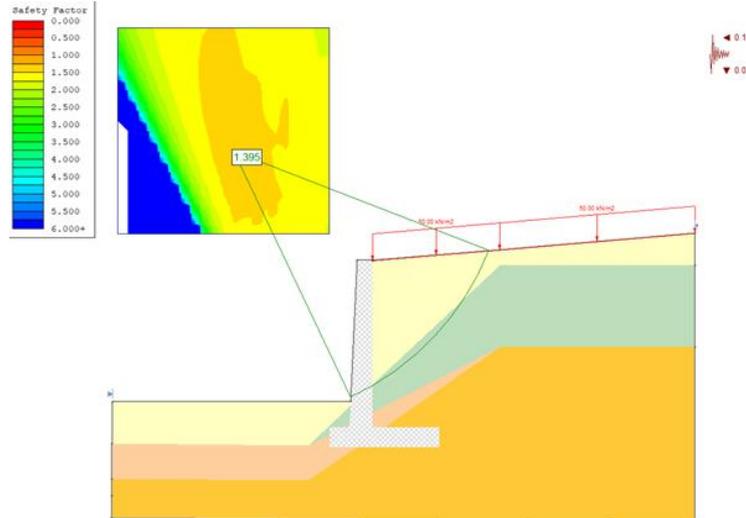
Dynamic case with containment structure

Fig. 5: Dynamic Analysis with containment structure. Source: own creation

FS=1.395 MEETS

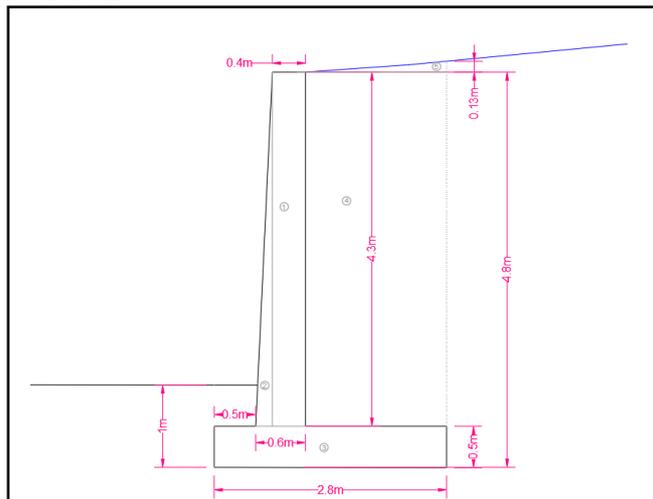
Fig. 6: Pre-sizing of containment structure - Slope 2. Source: Own creation

Slope 2 Design Containment Structure					
OVERTURNING					
INITIAL DATA					
γ_1	17.49 kN/m ³	α	6.00 °		
φ'_1	34.81 °	$\gamma_{concreto}$	23.50 kN/m ³		
c'_1	0.00 kN/m ²	$\gamma_{peso\ ideal}$	18.00 kN/m ³		
CALCULATIONS					
H'	4.940 m	$K_a = \cos\alpha \frac{\cos\alpha - \sqrt{\cos^2\alpha - \cos^2\phi'}}{\cos\alpha + \sqrt{\cos^2\alpha - \cos^2\phi'}}$			
K_a	0.277				
P_a	59.115 kN/m	P_h	58.791 kN/m		
P_v	6.179 kN/m	ΣM_o	96.810 kN(m/m)		
RESISTANT MOMENT					
SECTION	AREA (m ²)	WEIGHT / STRENGTH	ARM (m)	MOMENT (kN(m/m))	
1	1.72	40.42	0.80	32.34	
2	0.48	11.28	0.63	7.11	
3	1.40	32.90	1.40	46.06	
4	7.31	131.58	2.40	315.79	
5	0.12	2.16	2.13	4.60	
	P_v	6.18	6.18	38.19	
	ΣV	224.52	ΣM_R	444.08	
FS (OVERTURNING)	4.5872	MEET	$FS = \frac{\Sigma M_R}{\Sigma M_o}$		
GLIDE					
INITIAL DATA					
γ_2	17.77 kN/m ³	c'_2	0.99 kN/m ²		
φ'_2	37.00 °	D	1.00 m		
CALCULATIONS					
K_p	4.02	$P_p = \frac{1}{2} \gamma_2 D_1^2 K_p + 2c'_2 D_1 \sqrt{K_p}$

P_p	39.71 kN/m				
FS (GLIDE)	2.4742	MEET	$FS = \frac{(\Sigma V)\tan\delta' + Bc'_a + P_p}{P_a \cos\alpha}$		
CARRYING CAPACITY					
INITIAL DATA					
B	2.80 m	φ'_2	37.00 °		
N_c	55.63	N_y	66.19		
N_q	42.92	PARAMETERS ACCORDING TO THE MEYERHOF TABLE			
CALCULATIONS					
e	-0.147	$e < B/6$	$B/6$	0.47	
q_{max}	54.97	F_{yd}	1.00		
q	17.77	ψ°	14.67		
B'	3.09	F_{ci}	0.70		
F_{qd}	1.08	F_{yi}	0.00		
F_{cd}	1.08	q_u	617.16		
FS (BEARING CAPACITY)	11.2269	MEET	$FS = \frac{q_u}{q_{max}}$

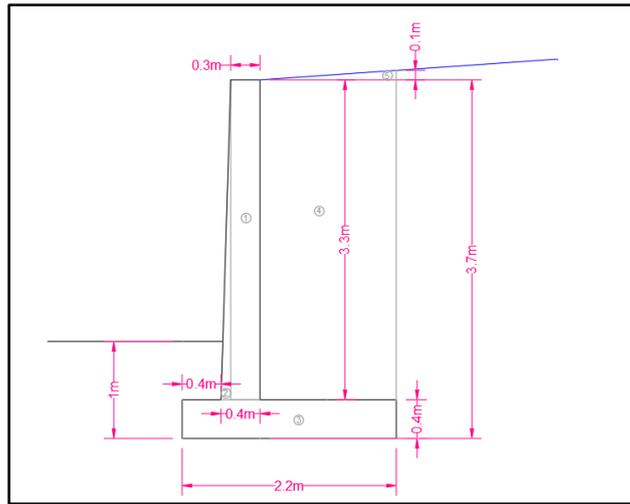
Fig. 7: Pre-sizing of containment structure - Slope 3. Source: Own creation

Slope 1	Slope 3	Slope 4	Slope 6
ANALYSIS OF STABILITY					
Static Case		1,515	1,251	1,265	1,469
Dynamic Case		1,325	1,086	1,145	0,787
DESIGN OF STABILITY					
Static Case	Does not require stabilization		1,526	1,917	2,076
Dynamic Case			1,405	1,786	1,934
SAFETY FACTORS OF THE STRUCTURE					
Overturning			4,3640	4,5064	2,5772
Slip	Does not require stabilization		2,4645	6,5801	4,5872
Carrying Capacity			8,8588	23,8943	11,6518

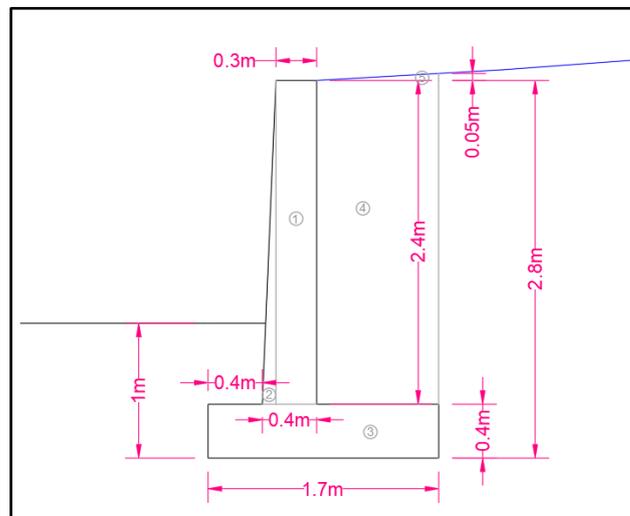
Fig. 8: Pre-sizing of containment structure - Slope 4. Source: Own creation

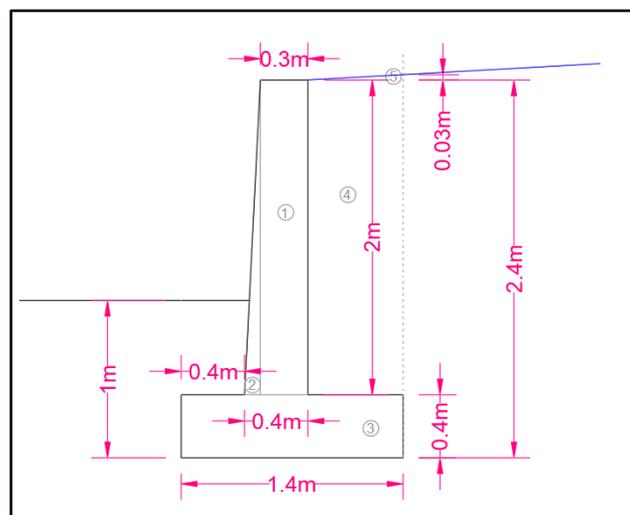
Fig. 9: Pre-sizing of containment structure - Slope 6. Source: Own creation
